## **NATIONAL TRANSPORTATION SAFETY BOARD**

# **ACCIDENT SITE EXAMINATION SUMMARY**

**WPR15FA195**

Location: Maricopa, CA  
Date: June 22, 2015  
Aircraft: N206PZ; S312 Tucano T MK1  
NTSB Investigator-in-Charge: Andrew Swick

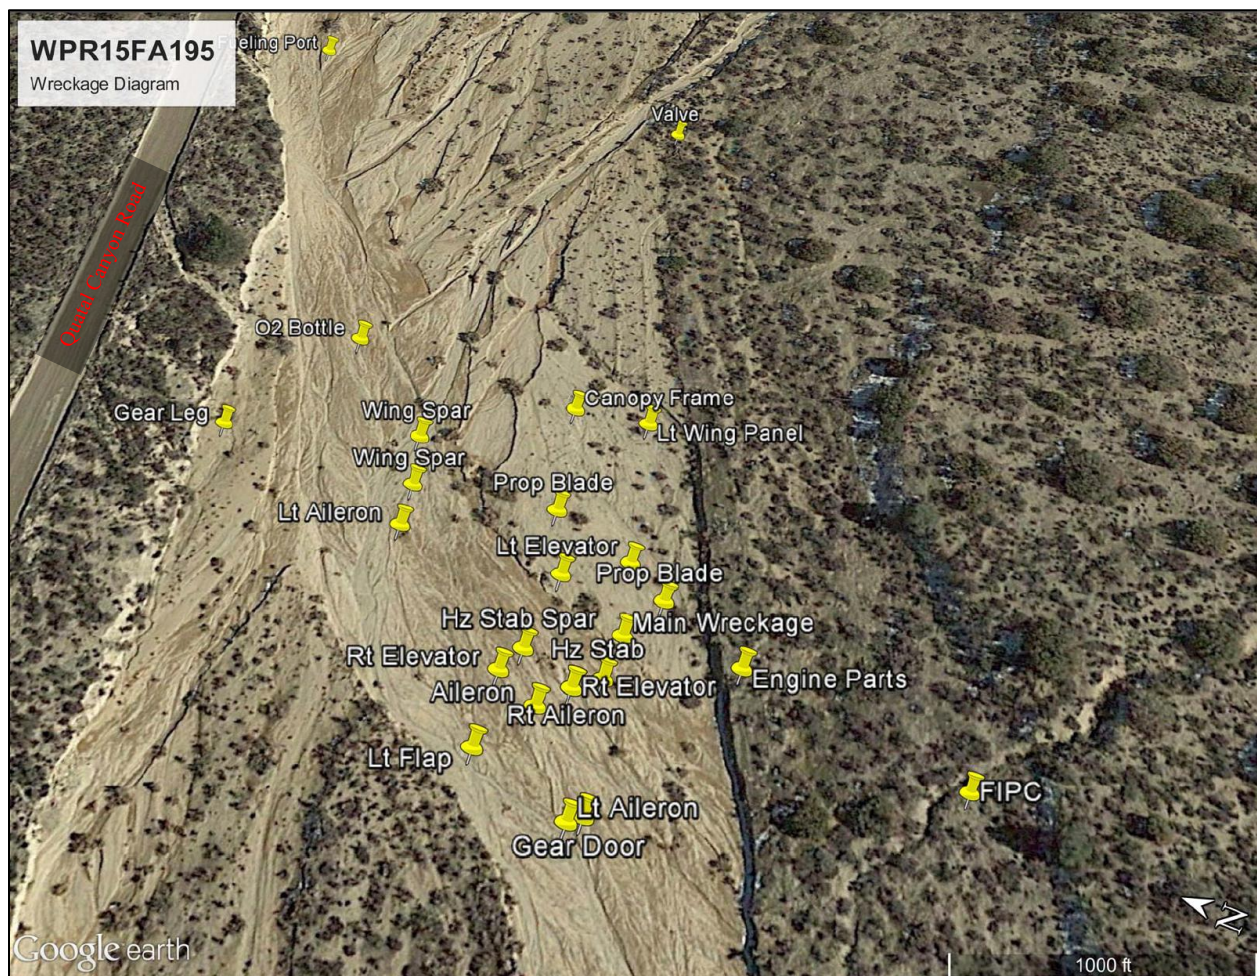
Figure 1-Aerial View of the Accident Site

Examination of the accident site revealed that the wreckage was in a dry creek bed. The airplane had been destroyed by high impact forces and a postimpact fire. The debris field was 641 feet in length and 355 feet wide. Postimpact fire was observed along the debris path and throughout the surrounding terrain. About 1 acre of land was burned.

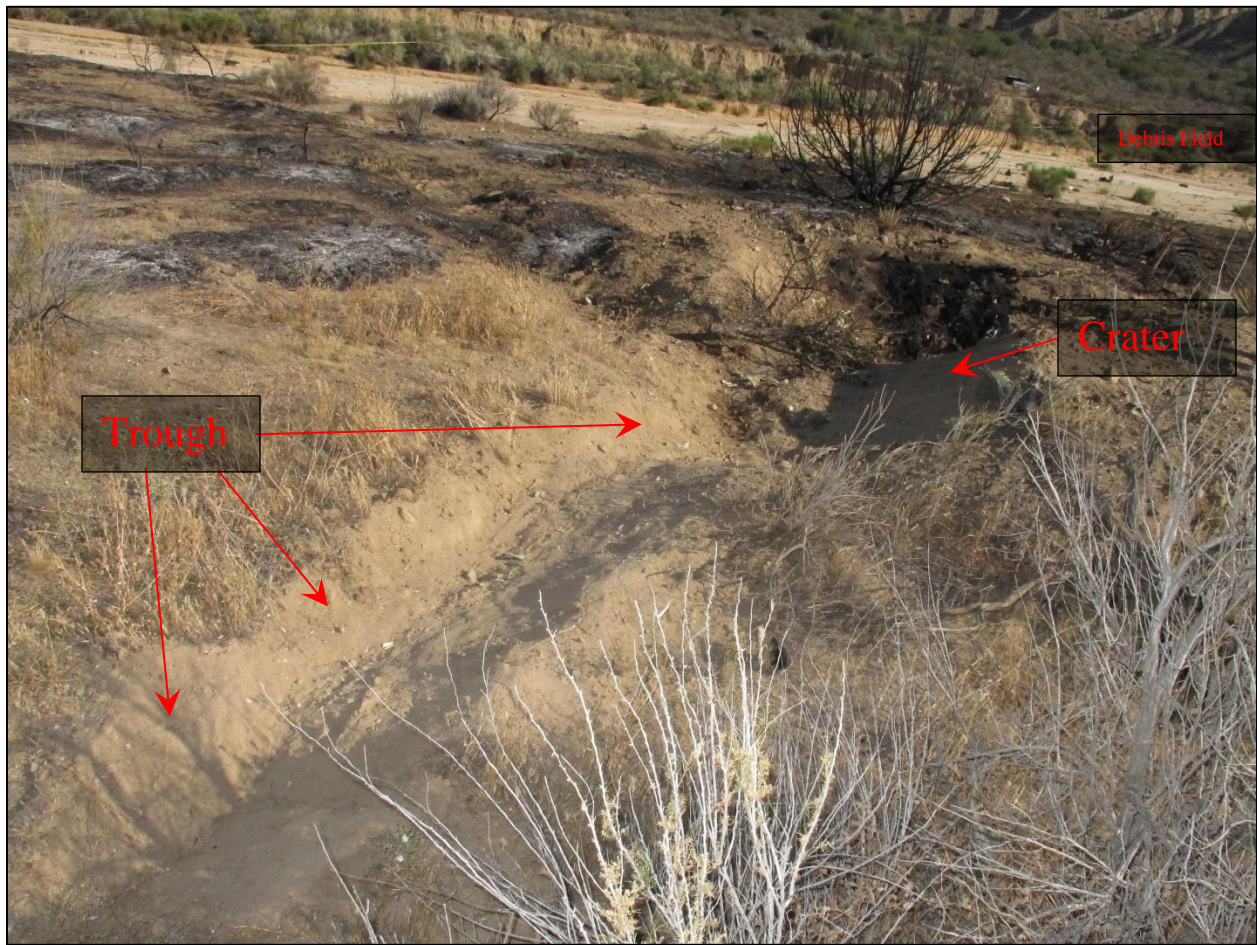
**Figure 2-Onsite FIPC**

The first identified point of contact (FIPC) was a trough of disturbed ground about 2 feet wide, about 20 feet in length and 1 foot in depth. The direction of the wreckage debris path was oriented a heading of a about 360 degrees magnetic from the FIPC to the main wreckage. A green light emitting diode (LED) navigation light was found near the FIPC. At the end of the trough was a crater was about 11 feet in diameter and about 5 feet deep. Two separated propeller blades, a landing gear strut with attached wheel and distorted pieces of sheet metal was found in and near the crater. The dirt in the crater was discolored and had the odor of fuel. The propeller blades revealed s-type bending, chordwise scoring, and leading edge gouging near the tip.

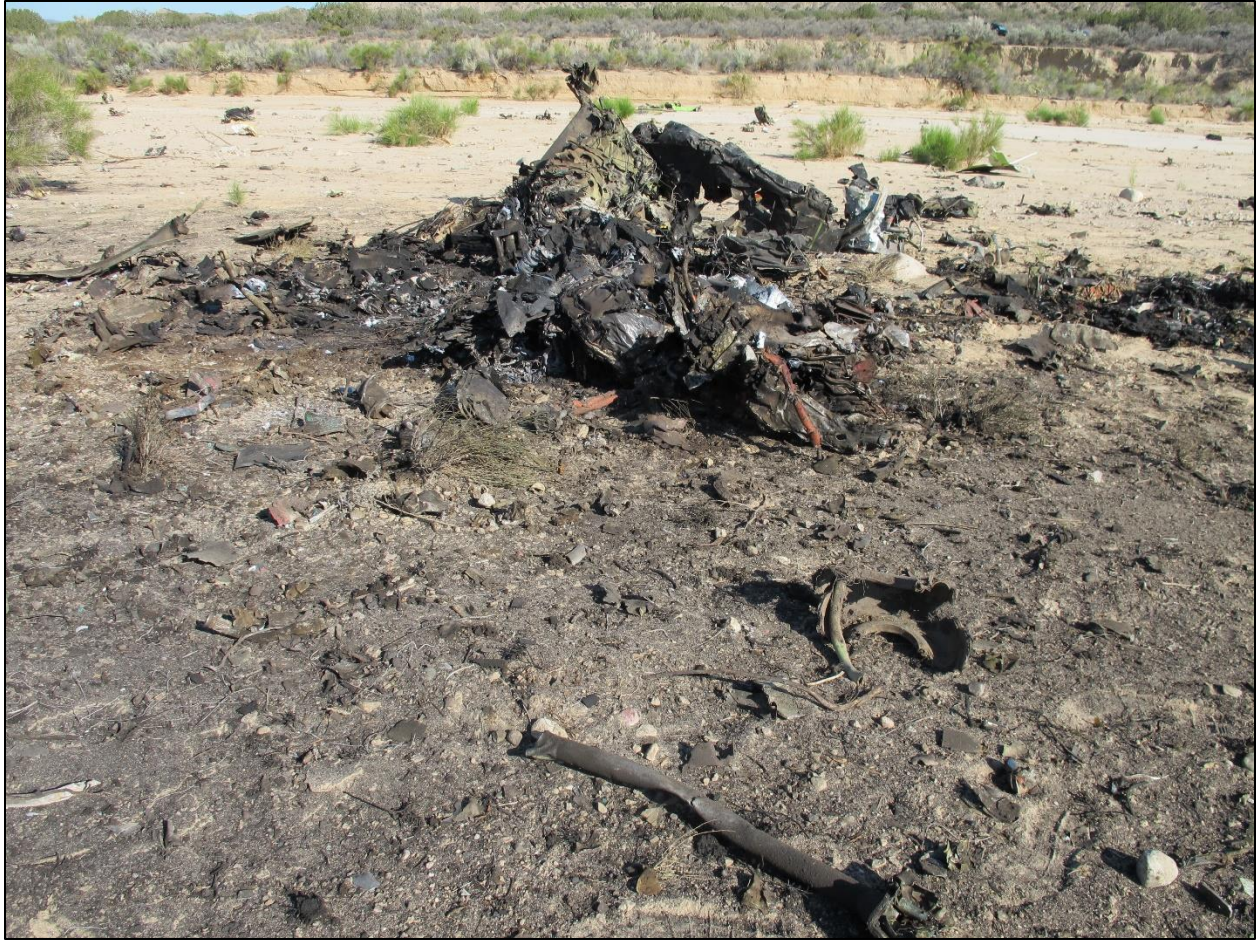
**Figure 3-Main Wreckage**

The main wreckage was found 180 feet from the FIPC. Another propeller blade, wing and fuselage sections and the engine bull gear assembly were found between the crater and the main wreckage. The main wreckage was twisted and distorted and consisted of the empennage, aft fuselage, firewall and the engine. Wire bundles and cabin instrumentation was found with the main wreckage and was burned and crushed. The pilot's body and attached parachute was found a few feet past the main wreckage. The canopy was found in several sections and was found past the main wreckage down the center of the debris field. A single-point refueling port was the last piece of wreckage in the debris field and was 641 feet from the FIPC. The aft fuselage and tail section structure was partially intact and cable control continuity was attained to the mid-section of the fuselage. Aileron control cables were located with the main wreckage. All primary flight controls were located in the debris field.

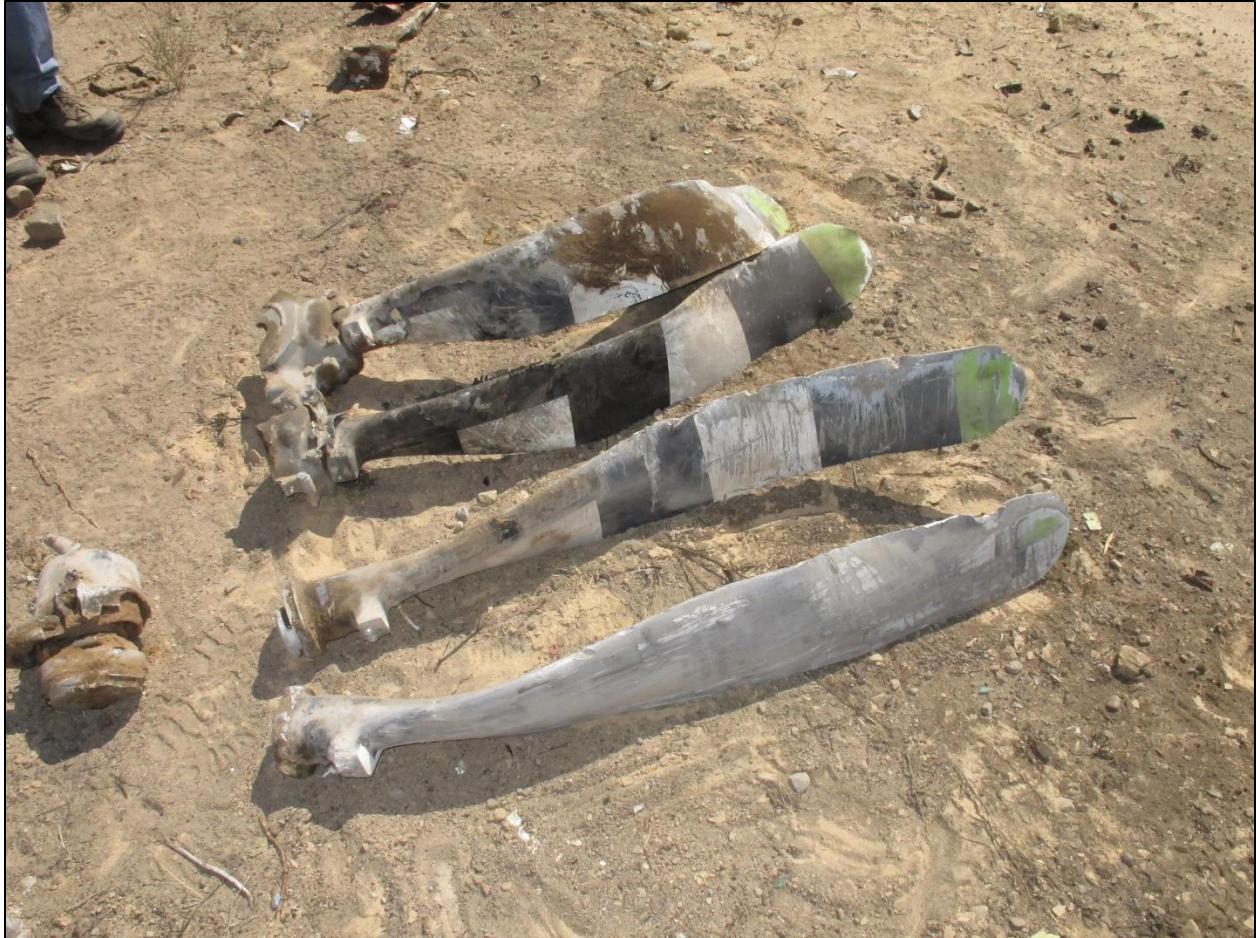
**Figure 4-Propeller Blades**

The last propeller blade was about 80 feet past the main wreckage. The last two propeller blades in the debris field revealed s-type bending, chordwise scoring, and leading edge gouging near the tips.

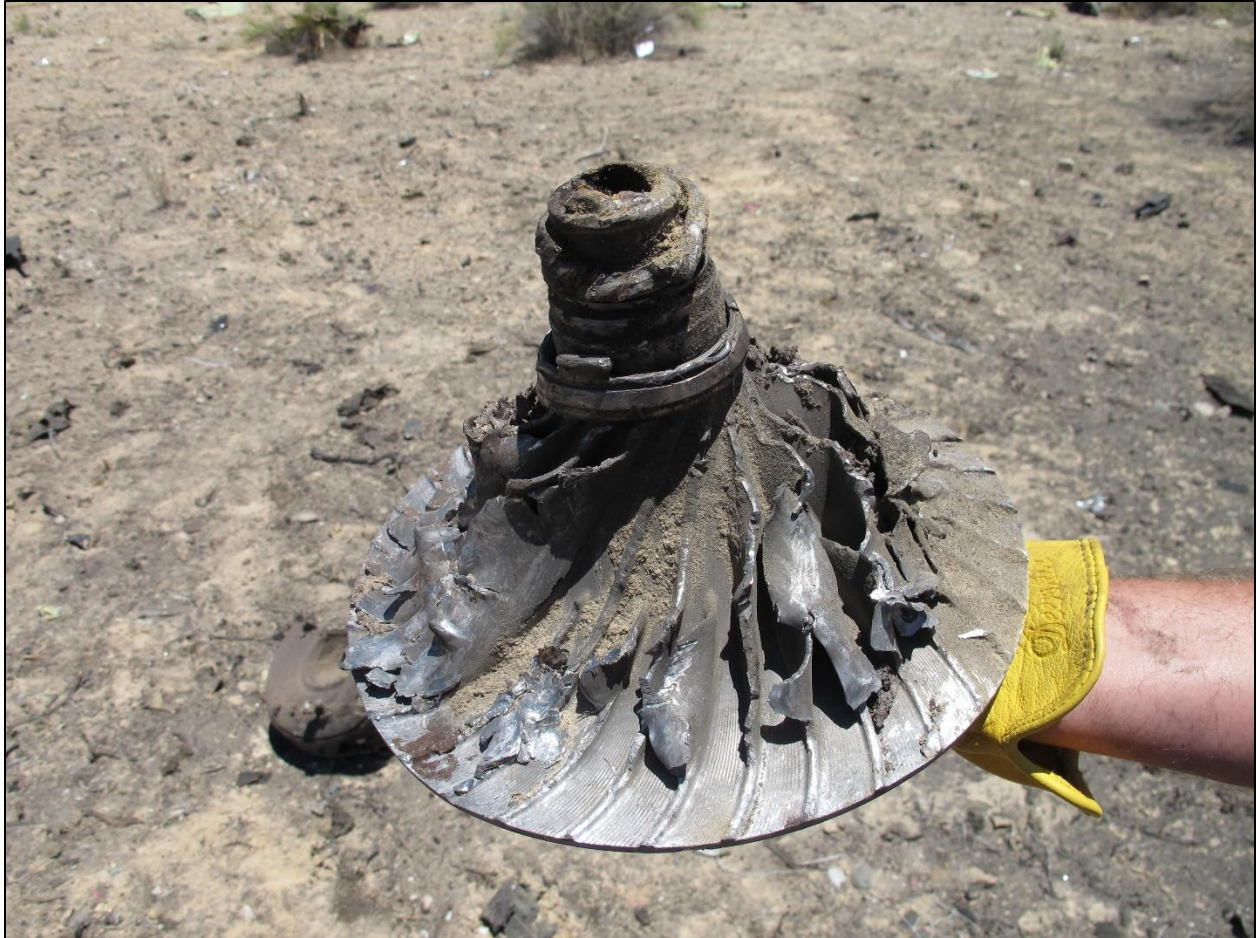
**Figure 5-Engine Compressor Impeller**

The engine had thermal discoloration, impact damage and was found in three sections. The first stage of compression impeller was visible and all of the blades revealed rotational signatures.

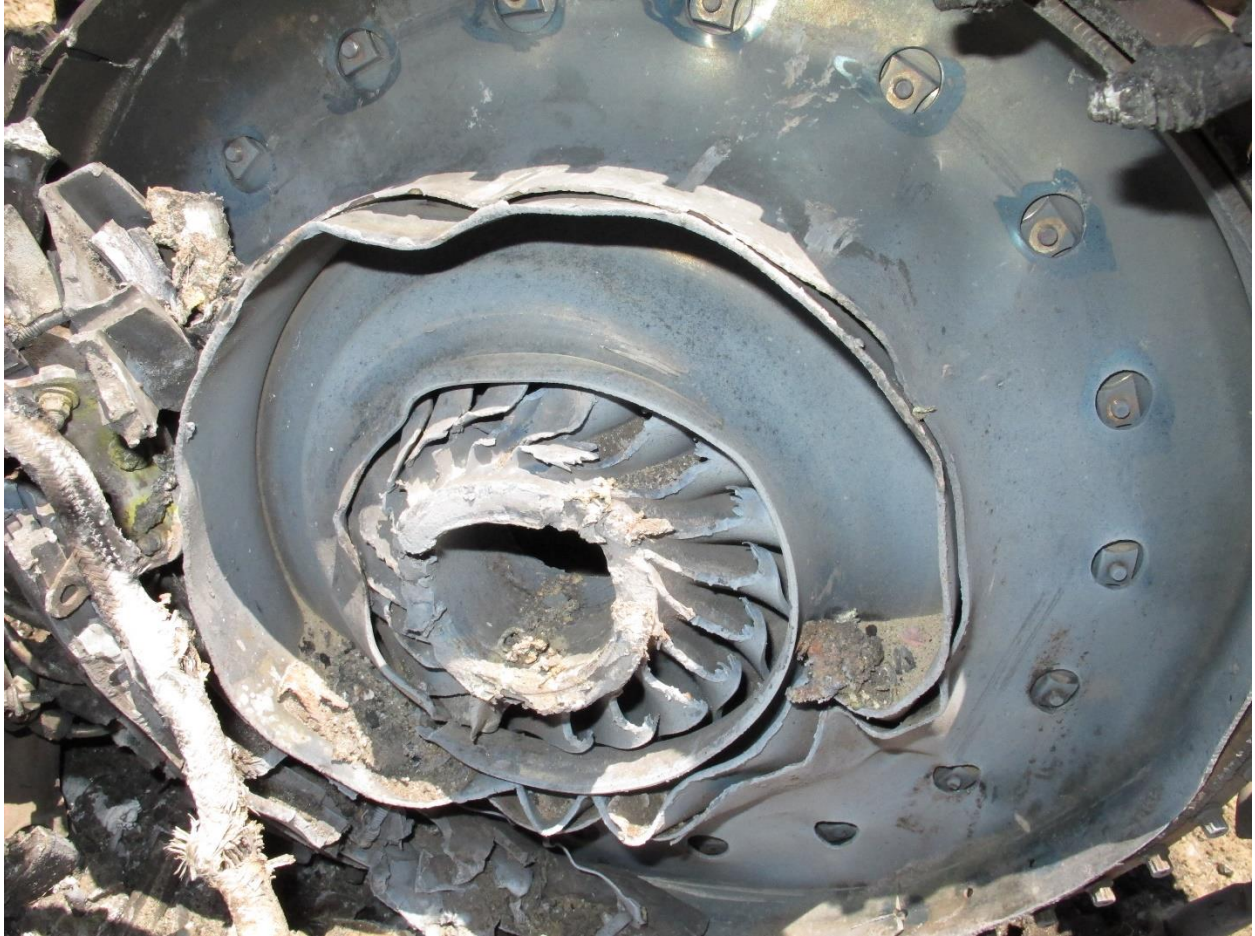
**Figure 6-Engine Compressor Housing**

The second-stage of compression was visible from the damaged housing and revealed rotational signatures.
